**Flood Control Project Maintenance
Levee Inspections**
LMA District Cover Sheet
Spring 2019 Levee Inspection Results

American River Flood Control District

Spring 2019 Levee Inspection Results

Waterway			Bank	Unit Miles
Unit No. 01 Arcade Creek			Left	2.08
	Spring (March - May)	Summer (June - August)	(September - November) Fall	Winter (December - February)
Unit Maintenance Rating (Fall Only)				
Date of Inspection	5/14/2019 - 5/14/2019			
DWR Inspector	Luz Dial			
Accompanied By	Ross Kawamura ARFCD

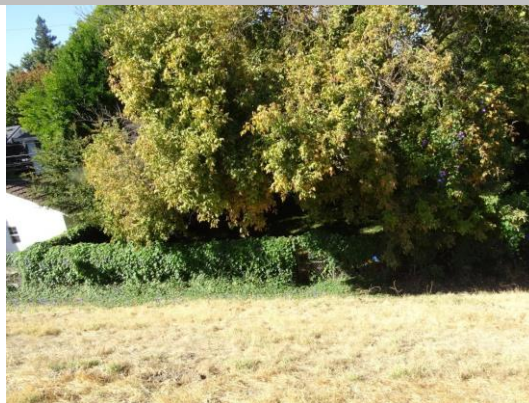
Photo 1 of 1 : SP_2019_NA0001_55_276_20190307_00210.jpg

LM Start	5.57	Rating **	M	Issue No.	276
LM End	5.57	Issue Type +	En	Location *	LS
Category	Earthen Levee			GPS Latitude/Longitude	
				Start	End
Item	Vegetation			38.575743 °	38.575743 °
				-121.423125 °	-121.423125 °
DWR ID	DWR_NA0001_04_f_2018_276				
Comment Code					
V6 : Landscaping					
Inspector Comment					
Vegetation on chainlink fence obstructs the view of the levee toe.

View of vegetation on chainlink fence that obstructs view of levee toe.
Fall 2018

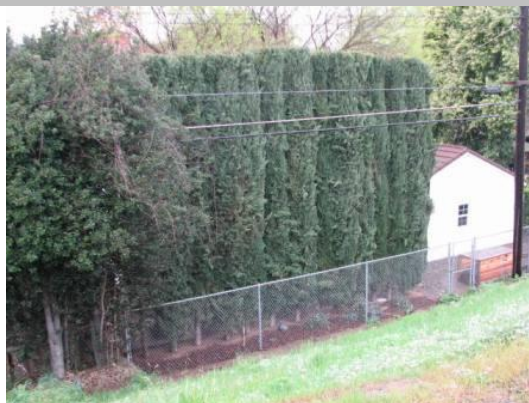
Photo 1 of 1 : SP_2019_NA0001_55_52_20190307_00044.jpg

LM Start	5.60	Rating **	U	Issue No.	52
LM End	5.60	Issue Type +	En	Location *	LS
Category	Earthen Levee			GPS Latitude/Longitude	
				Start	End
Item	Vegetation			38.575379 °	38.575379 °
				-121.423201 °	-121.423201 °
DWR ID	DWR_NA0001_04_s_2012_52				
Comment Code					
V6 : Landscaping					
Inspector Comment					
Helix sky pencil trees within 10-ft of the levee toe obstruct visibility and access.

03/16/2012 Landscaping obstructs visibility and access.

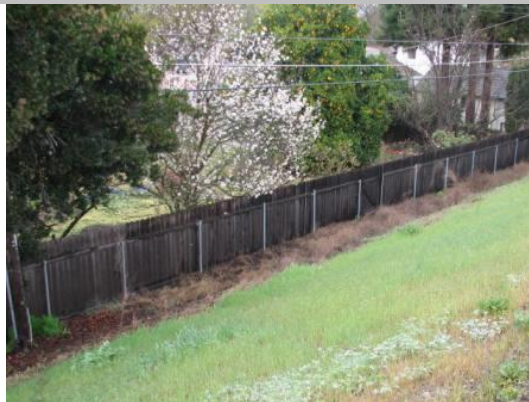
Photo 1 of 1 : SP_2019_NA0001_55_54_20190307_00046.jpg

LM Start	5.62	Rating **	U	Issue No.	54
LM End	5.62	Issue Type +	En	Location *	LS
Category	Earthen Levee			GPS Latitude/Longitude	
				Start	End
Item	Encroachments			38.575024 °	38.575024 °
				-121.423277 °	-121.423277 °
DWR ID	DWR_NA0001_04_s_2012_54				
Comment Code					
FE : Fence					
Inspector Comment					
Wood privacy fence and landscaping within 10-ft of the levee toe obstruct access and visibility. Fence does not appear to have a permit.

03/16/2012 Wood privacy fence completely obstructs access and visibility.

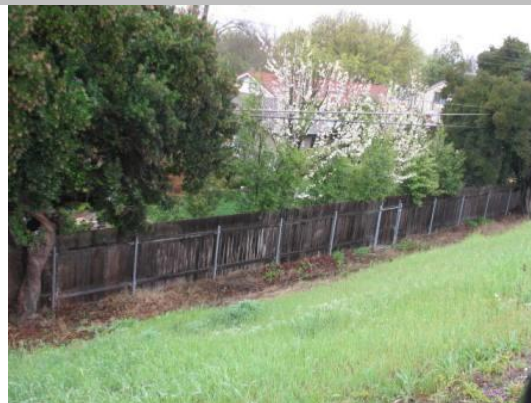
Photo 1 of 1 : SP_2019_NA0001_55_55_20190307_00047.jpg

LM Start	5.64	Rating **	U	Issue No.	55
LM End	5.64	Issue Type +	En	Location *	LS
Category	Earthen Levee			GPS Latitude/Longitude	
				Start	End
Item	Encroachments			38.574786 °	38.574786 °
				-121.423324 °	-121.423324 °
DWR ID	DWR_NA0001_04_s _ 2012_55				
Comment Code					
FE : Fence					
Inspector Comment					
Wood privacy fence within 10-ft of the levee toe obstructs visibility and does not appear to have a permit.

03/16/2012 Wood privacy fence completely obstructs access and visibility.

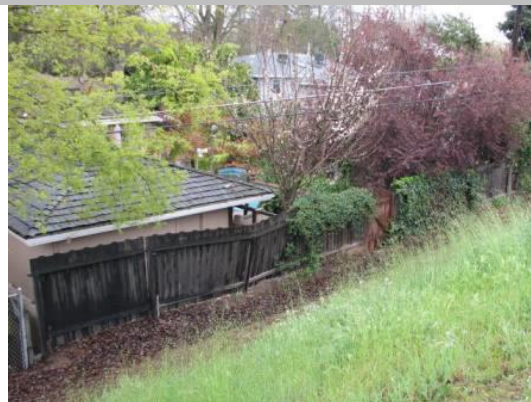
Photo 1 of 1 : SP_2019_NA0001_55_57_20190307_00048.jpg

LM Start	5.70	Rating **	U	Issue No.	57
LM End	5.70	Issue Type +	En	Location *	LS
Category	Earthen Levee			GPS Latitude/Longitude	
				Start	End
Item	Encroachments			38.573927 °	38.573927 °
				-121.423480 °	-121.423480 °
DWR ID	DWR_NA0001_04_s _ 2012_57				
Comment Code					
FE : Fence					
Inspector Comment					
Wood privacy fence with ivy obstructs visibility.

03/16/2012 Wood privacy fence completely obstructs access and visibility.

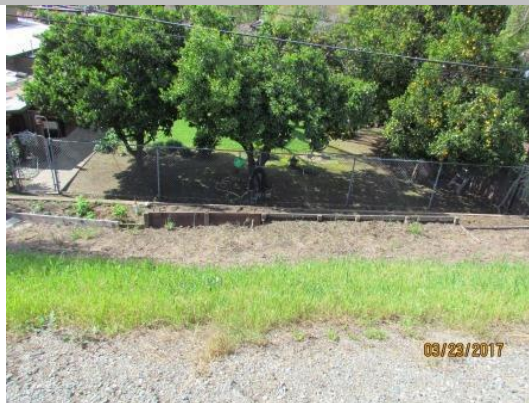
Photo 1 of 1 : SP_2019_NA0001_55_58_20190307_00049.jpg

LM Start	5.73	Rating **	M	Issue No.	58
LM End	5.73	Issue Type +	En	Location *	LS
Category	Earthen Levee			GPS Latitude/Longitude	
				Start	End
Item	Vegetation			38.573501 °	38.573501 °
				-121.423602 °	-121.423602 °
DWR ID	DWR_NA0001_04_s _ 2012_58				
Comment Code					
V6 : Landscaping					
Inspector Comment					
Resident built a garden on the levee slope.

View of the garden at the levee toe.

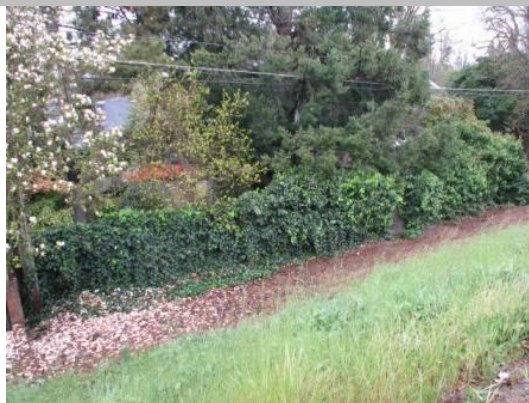
Photo 1 of 1 : SP_2019_NA0001_55_61_20190307_00051.jpg

LM Start	5.78	Rating **	U	Issue No.	61
LM End	5.78	Issue Type +	En	Location *	LS
Category	Earthen Levee			GPS Latitude/Longitude	
				Start	End
Item	Vegetation			38.572827 °	38.572827 °
				-121.423786 °	-121.423786 °
DWR ID	DWR_NA0001_04_s _ 2012_61				
Comment Code					
V6 : Landscaping					
Inspector Comment					
Dense ivy and shrubs are within 10-ft of the levee toe.

03/16/2012 Landscaping obstructs access and visibility.

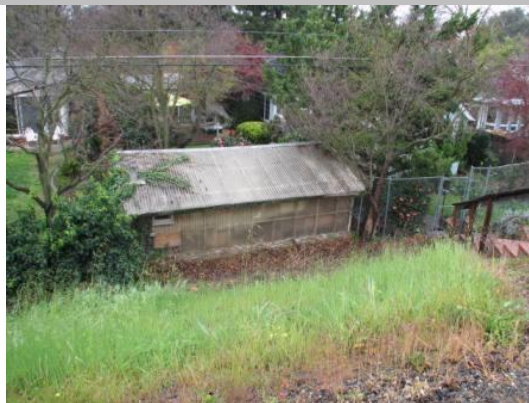
Photo 1 of 1 : SP_2019_NA0001_55_63_20190307_00052.jpg

LM Start	5.81	Rating **	U	Issue No.	63
LM End	5.81	Issue Type +	En	Location *	LS
Category	Earthen Levee			GPS Latitude/Longitude	
				Start	End
Item	Encroachments			38.572325 °	38.572325 °
				-121.423913 °	-121.423913 °
DWR ID	DWR_NA0001_04_s _ 2012_63				
Comment Code					
BU : Building					
Inspector Comment					
Wood and fiberglass structure within 10-ft of the levee toe is not listed on the levee log as permitted. Chainlink fence and irrigation system do not appear to have a permit.

03/16/2012 Wood and fiberglass structure is within 15' of levee toe.

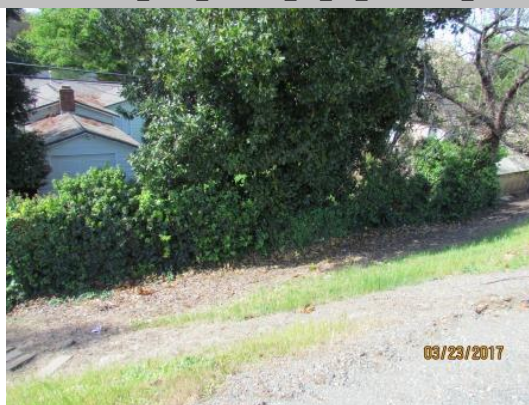
Photo 1 of 1 : SP_2019_NA0001_55_64_20190307_00053.jpg

LM Start	5.82	Rating **	M	Issue No.	64
LM End	5.82	Issue Type +	En	Location *	LS
Category	Earthen Levee			GPS Latitude/Longitude	
				Start	End
Item	Vegetation			38.572207 °	38.572207 °
				-121.423933 °	-121.423933 °
DWR ID	DWR_NA0001_04_s _ 2012_64				
Comment Code					
V6 : Landscaping					
Inspector Comment					
Dense shrubs on levee toe obstruct visibility.

View of the shrubs at the levee toe.

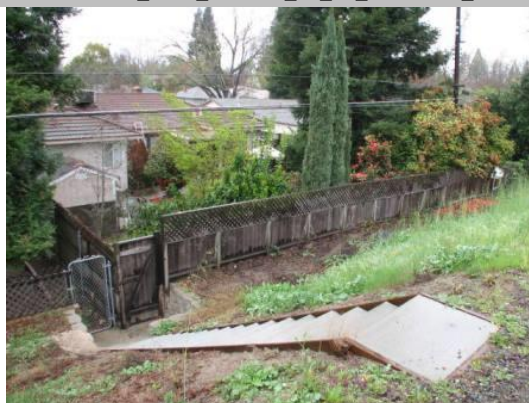
Photo 1 of 1 : SP_2019_NA0001_55_65_20190307_00054.jpg

LM Start	5.83	Rating **	U	Issue No.	65
LM End	5.83	Issue Type +	En	Location *	LS
Category	Earthen Levee			GPS Latitude/Longitude	
				Start	End
Item	Encroachments			38.572067 °	38.572067 °
				-121.423970 °	-121.423970 °
DWR ID	DWR_NA0001_04_s _ 2012_65				
Comment Code					
FE : Fence					
Inspector Comment					
Extended privacy fence blocks visibility. Stairs and retaining wall within 10-ft of levee toe are permitted under 6498.

03/16/2012 Wood privacy fence completely obstructs access and visibility.

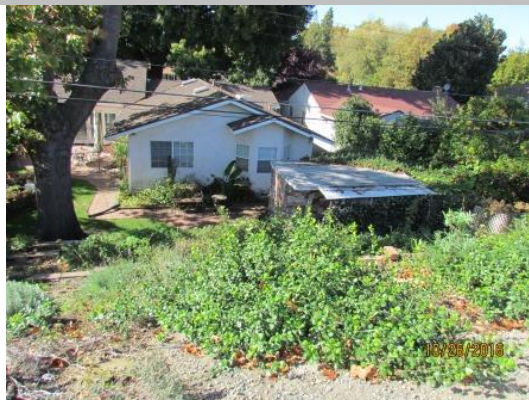
Photo 1 of 1 : SP_2019_NA0001_55_68_20190307_00056.jpg

LM Start	5.87	Rating **	U	Issue No.	68
LM End	5.87	Issue Type +	En	Location *	LS
Category	Earthen Levee			GPS Latitude/Longitude	
				Start	End
Item	Vegetation			38.571525 °	38.571525 °
				-121.424152 °	-121.424152 °
DWR ID	DWR_NA0001_04_s_2018_68				
Comment Code					
V6 : Landscaping					
Inspector Comment					
Levee slope has been landscaped. This obstructs visibility.

Levee slope is heavily landscaped; retaining wall has been constructed at the levee toe.

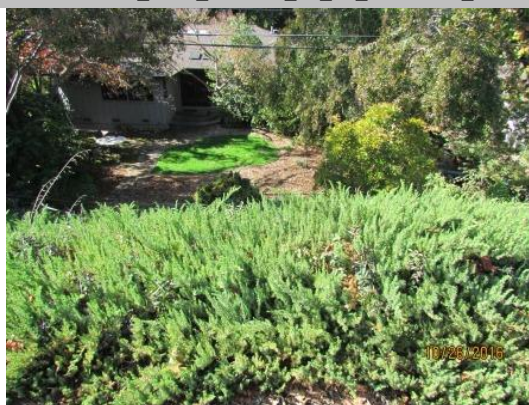
Photo 1 of 1 : SP_2019_NA0001_55_70_20190307_00057.jpg

LM Start	5.88	Rating **	U	Issue No.	70
LM End	5.88	Issue Type +	En	Location *	LS
Category	Earthen Levee			GPS Latitude/Longitude	
				Start	End
Item	Vegetation			38.571269 °	38.571269 °
				-121.424167 °	-121.424167 °
DWR ID	DWR_NA0001_04_s_2012_70				
Comment Code					
V6 : Landscaping					
Inspector Comment					
Levee slope has been landscaped. This obstructs visibility.

View of the vegetation on the landside levee slope.

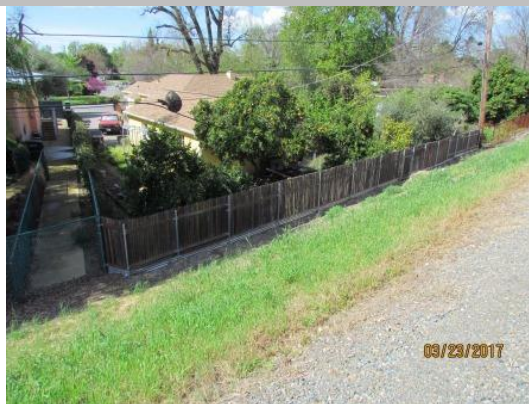
Photo 1 of 1 : SP_2019_NA0001_55_88_20190307_00074.jpg

LM Start	5.91	Rating **	U	Issue No.	88
LM End	5.91	Issue Type +	En	Location *	LS
Category	Earthen Levee			GPS Latitude/Longitude	
				Start	End
Item	Encroachments			38.570864 °	38.570864 °
				-121.424212 °	-121.424212 °
DWR ID	DWR_NA0001_04_f_2012_88				
Comment Code					
FE : Fence					
Inspector Comment					
Wooden privacy fence does not have a permit according to the levee log.

View of the wood privacy fence completely obstructing access and visibility.

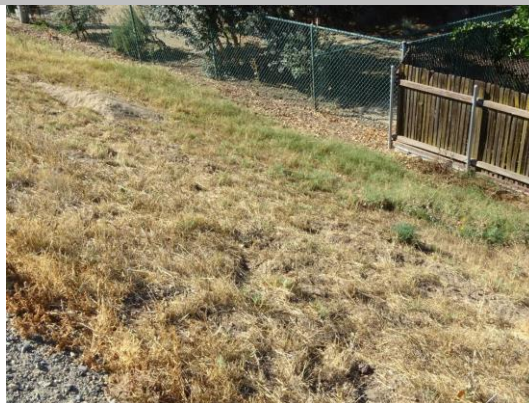
Photo 1 of 1 : SP_2019_NA0001_55_273_20190307_00209.jpg

LM Start	5.92	Rating **	M	Issue No.	273
LM End	5.94	Issue Type +	Ma	Location *	LS
Category	Earthen Levee			GPS Latitude/Longitude	
				Start	End
Item	Animal Control			38.570755 °	38.570395 °
				-121.424206 °	-121.424237 °
DWR ID	DWR_NA0001_04_f_2018_273				
Comment Code					
A3 : No rodents visible, but rodent burrows visible; need to backfill and compact or grout burrows.					
Inspector Comment					
Backfill animal holes.

View of animal burrows. Fall 2018

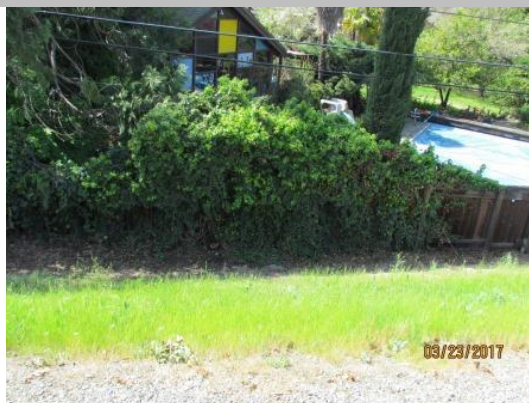
Photo 1 of 1 : SP_2019_NA0001_55_72_20190307_00059.jpg

LM Start	5.95	Rating **	U	Issue No.	72
LM End	5.95	Issue Type +	En	Location *	LS
Category	Earthen Levee			GPS Latitude/Longitude	
				Start	End
Item	Encroachments			38.570389 °	38.570389 °
				-121.424231 °	-121.424231 °
DWR ID	DWR_NA0001_04_s_2012_72				
Comment Code					
FE : Fence					
Inspector Comment					
Wood fence and landscaping within 10-ft of the levee toe obstructs visibility.

View of the wood privacy fence completely obstructing access and visibility.

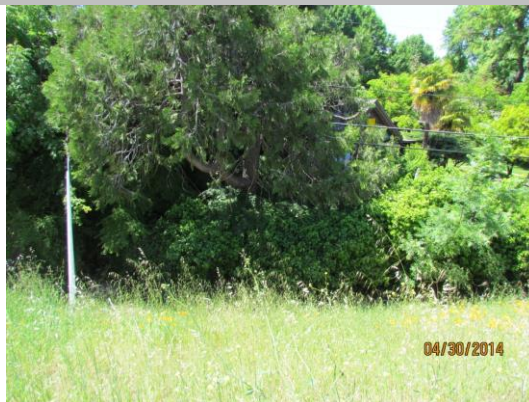
Photo 1 of 1 : SP_2019_NA0001_55_71_20190307_00058.jpg

LM Start	5.95	Rating **	M	Issue No.	71
LM End	5.95	Issue Type +	En	Location *	LS
Category	Earthen Levee			GPS Latitude/Longitude	
				Start	End
Item	Vegetation			38.570375 °	38.570375 °
				-121.424231 °	-121.424231 °
DWR ID	DWR_NA0001_04_s_2012_71				
Comment Code					
V6 : Landscaping					
Inspector Comment					
Landscaping and garden are within 10-ft of the levee toe.

View of the landscaping at the landside levee toe.

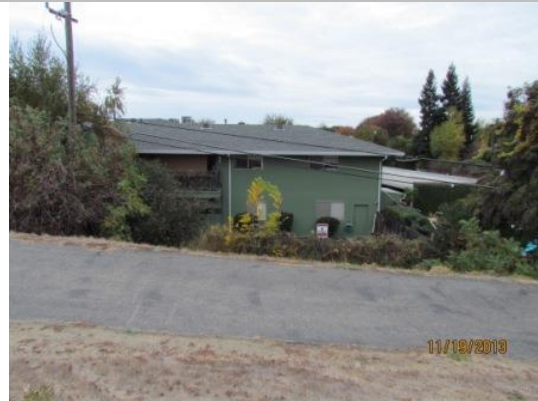
Photo 1 of 1 : SP_2019_NA0001_55_211_20190307_00177.jpg

LM Start	5.98	Rating **	M	Issue No.	211
LM End	5.98	Issue Type +	En	Location *	LS
Category	Earthen Levee			GPS Latitude/Longitude	
				Start	End
Item	Encroachments			38.569893 °	38.569893 °
				-121.424310 °	-121.424310 °
DWR ID	DWR_NA0001_04_s_2012_211				
Comment Code					
FE : Fence					
Inspector Comment					
An apartment complex's privacy fence and shrubs are within 10-ft of the slope and obstruct visibility.

View of the fence at the landside levee toe.

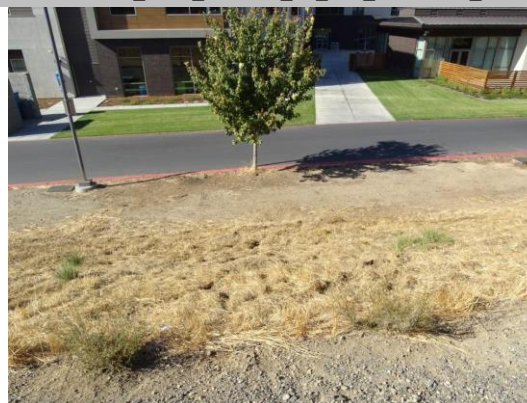
Photo 1 of 1 : SP_2019_NA0001_55_271_20190307_00208.jpg

LM Start	6.29	Rating **	M	Issue No.	271
LM End	6.29	Issue Type +	Ma	Location *	LS
Category	Earthen Levee			GPS Latitude/Longitude	
				Start	End
Item	Animal Control			38.565472 °	38.565472 °
				-121.423240 °	-121.423240 °
DWR ID	DWR_NA0001_04_f_2018_271				
Comment Code					
A3 : No rodents visible, but rodent burrows visible; need to backfill and compact or grout burrows.					
Inspector Comment					
Backfill rodent holes.

View of animal holes. Fall 2018

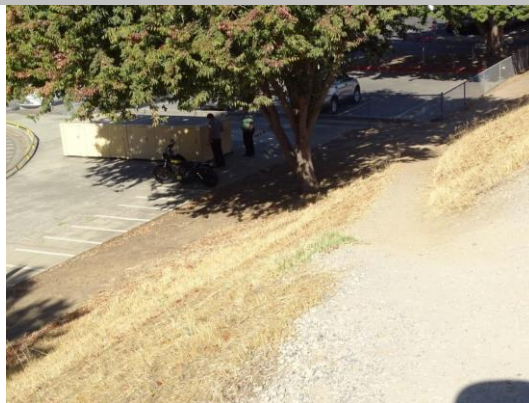
Photo 1 of 1 : SP_2019_NA0001_55_270_20190307_00207.jpg

LM Start	6.34	Rating **	A/W	Issue No.	270
LM End	6.34	Issue Type +	Ma	Location *	LS
Category	Earthen Levee			GPS Latitude/Longitude	
				Start	End
Item	Slope Stability			38.564833 °	38.564833 °
				-121.422947 °	-121.422947 °
DWR ID	DWR_NA0001_04_f_2018_270				
Comment Code					
S2 : Repair the levee slope damaged by foot traffic and prevent access where possible.					
Inspector Comment					
Monitor footpath.

View of footpath on slope. Fall 2018

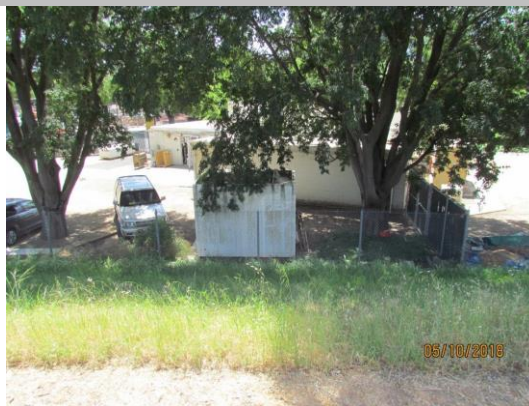
Photo 1 of 1 : SP_2019_NA0001_55_185_20190307_00156.jpg

LM Start	6.60	Rating **	M	Issue No.	185
LM End	6.60	Issue Type +	En	Location *	LS
Category	Earthen Levee			GPS Latitude/Longitude	
				Start	End
Item	Encroachments			38.561448 °	38.561448 °
				-121.421071 °	-121.421071 °
DWR ID	DWR_NA0001_04_s _ 2018_185				
Comment Code					
BU : Building					
Inspector Comment					
A storage shed is within 10 feet of the landside levee toe.

View of storage shed, Spring 2018.

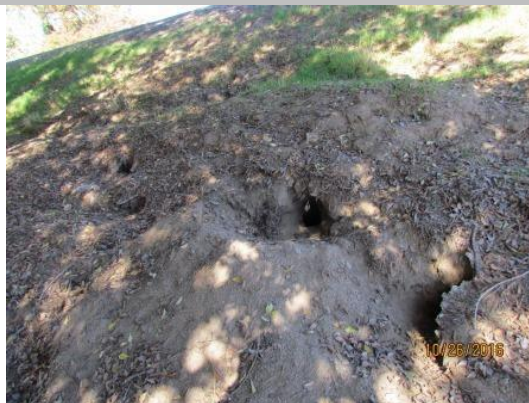
Photo 1 of 2 : SP_2019_NA0001_55_240_20190307_00192.jpg

LM Start	6.62	Rating **	M	Issue No.	240
LM End	6.65	Issue Type +	Ma	Location *	LS
Category	Earthen Levee			GPS Latitude/Longitude	
				Start	End
Item	Animal Control			38.561121 °	38.560883 °
				-121.420766 °	-121.420514 °
DWR ID	DWR_NA0001_04_s _ 2017_240				
Comment Code					
A3 : No rodents visible, but rodent burrows visible; need to backfill and compact or grout burrows.					
Inspector Comment					
Only two rodent burrows were visible due to vegetation.

View of a rodent burrows at the landside levee toe.

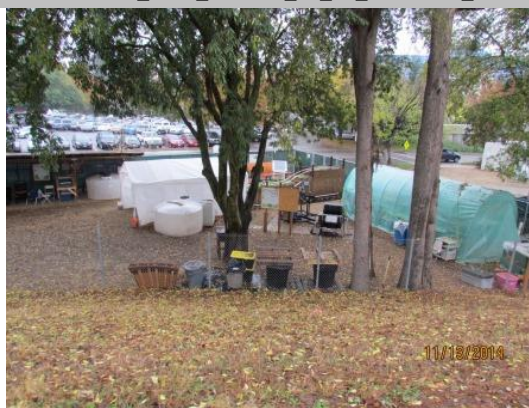
Photo 1 of 1 : SP_2019_NA0001_55_51_20190307_00043.jpg

LM Start	6.62	Rating **	M	Issue No.	51
LM End	6.62	Issue Type +	En	Location *	LS
Category	Earthen Levee			GPS Latitude/Longitude	
				Start	End
Item	Encroachments			38.561117 °	38.561117 °
				-121.420749 °	-121.420749 °
DWR ID	DWR_NA0001_04_f_2013_51				
Comment Code					
MA : Material					
Inspector Comment					
Pipe and other material are stored within 10 feet of landside levee toe.

View of the material stored at the landside levee toe.

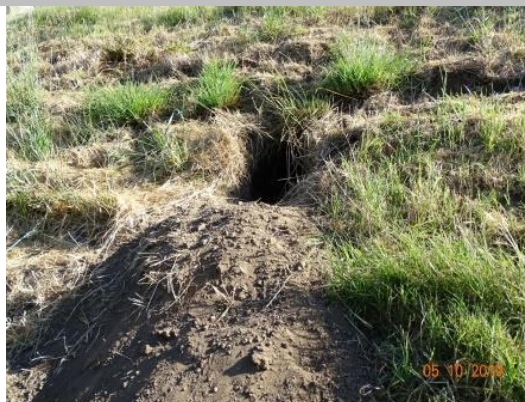
Photo 1 of 1 : SP_2019_NA0001_55_285_20190515_00271.jpg

LM Start	6.87	Rating **	U	Issue No.	285	
LM End	6.87	Issue Type +	Ma	Location *	LS	
Category	Earthen Levee			GPS Latitude/Longitude		
				Start		End
Item	Animal Control			38.558618 °		38.558618 °
				-121.417515 °		-121.417515 °
DWR ID	DWR_NA0001_04_s_2019_285					
Comment Code						
A3 : No rodents visible, but rodent burrows visible; need to backfill and compact or grout burrows.						
Inspector Comment						
There is a large animal burrow into the levee slope.

View looking north at large animal hole on the levee slope within the City facility. Spring 2019

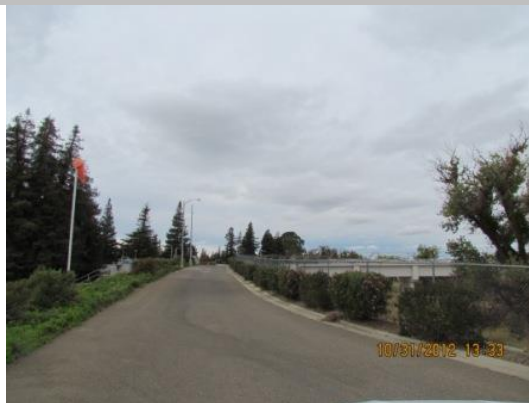
Photo 1 of 1 : SP_2019_NA0001_55_140_20190307_00119.jpg

LM Start	6.88	Rating **	M	Issue No.	140
LM End	6.89	Issue Type +	En	Location *	WS
Category	Earthen Levee			GPS Latitude/Longitude	
				Start	End
Item	Vegetation			38.558592 °	38.558528 °
				-121.417407 °	-121.417248 °
DWR ID	DWR_NA0001_04_f_2012_140				
Comment Code					
V6 : Landscaping					
Inspector Comment					
Bushes at the waterside hinge obstruct visibility of the waterside slope from the levee crown.

View of landscaping at waterside hinge obstructing visibility.

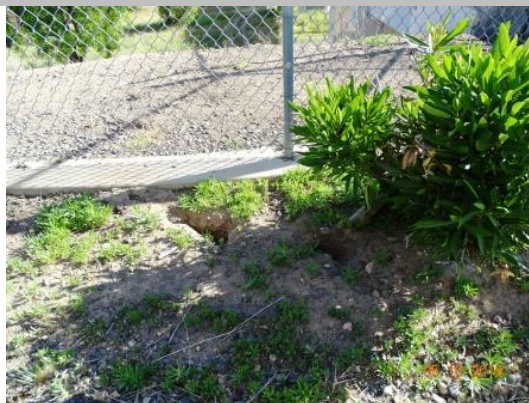
Photo 1 of 2 : SP_2019_NA0001_55_286_20190515_00272.jpg

LM Start	6.88	Rating **	U	Issue No.	286
LM End	6.88	Issue Type +	Ma	Location *	WS
Category	Earthen Levee			GPS Latitude/Longitude	
				Start	End
Item	Animal Control			38.558585 °	38.558585 °
				-121.417373 °	-121.417373 °
DWR ID	DWR_NA0001_04_s_2019_286				
Comment Code					
A3 : No rodents visible, but rodent burrows visible; need to backfill and compact or grout burrows.					
Inspector Comment					
Backfill numerous animal holes - two at the crown and the remainder on the upper slope.

View looking north at animal holes on the levee crown within the City facility. Spring 2019

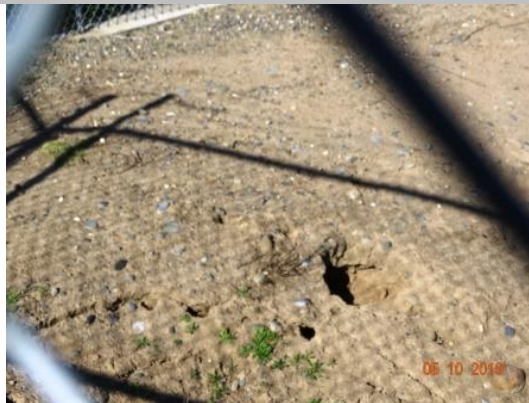
Photo 2 of 2 : SP_2019_NA0001_55_286_20190515_00273.jpg

LM Start	6.88	Rating **	U	Issue No.	286 (cont)
LM End	6.88	Issue Type +	Ma	Location *	WS

View looking downstream at animal holes on the upper slope outside the City facility. Spring 2019

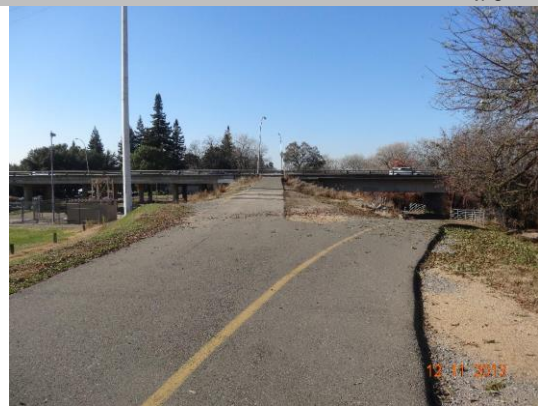
Photo 1 of 3 : UCIP_SP_2019_30023_55394.jpg

Comment Code					
Inspector Comment					
FS_ID:30023 DS_ID:24319 EP_NO: 3596 Repair Type: Non-Urgent Crossing Status: Indicator Found UCIP Comments: 12/11/2013 Need to contact owners to determine how crossing was abandoned. (DWR UCIP - O. Magana) FIELD_STRUCT_DESC: *ABANDONED* [Sump No. 91] 4 of 4: 48-inch corrugated metal (CM) drainage pipe through the levee, 20 feet below the crown. Pump station is also referenced as the Power Inn Road Plant. Two corrugated metal (CM) cutoff walls around pipe under each shoulder. Slide gate with control pedestal in CM pipe riser located on the waterside (WS) slope. Reinforced concrete discharge box is located on the WS toe. Flap gate is located on the WS end. Slide gate with control pedestal in collection sump located on the landside (LS). 60-inch discharge pipe extends from box across the berm to the riverbank. Pumping plant is located on the LS toe. (48-inch pipe abandoned and CM riser cut 2 feet below ground surface authorized under Permit No. 3596A, 1998 – City of Sacramento; three 30-inch and one 48-inch pipes authorized under Permit No. 3596, 3596A, 1962 - County of Sacramento Manlove Drainage Assessment District; 60-inch pipe authorized under Permit No. 5894, 1970 - City of Sacramento) [Additional Reference(s): DWR Levee Log, 2002] FS Date: 12/11/2013

Overview of levee crown at crossings.

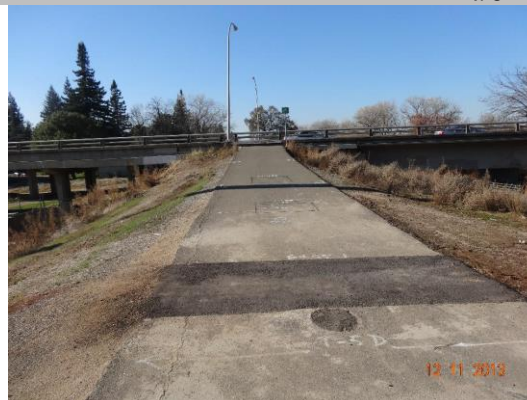
Photo 2 of 3 : UCIP_SP_2019_30023_55392.jpg

Comment Code						
Inspector Comment						
FS_ID:30023 DS_ID:24319 EP_NO: 3596 Repair Type: Non-Urgent Crossing Status: Indicator Found UCIP Comments: 12/11/2013 Need to contact owners to determine how crossing was abandoned. (DWR UCIP - O. Magana) FIELD_STRUCT_DESC: *ABANDONED* [Sump No. 91] 4 of 4: 48-inch corrugated metal (CM) drainage pipe through the levee, 20 feet below the crown. Pump station is also referenced as the Power Inn Road Plant. Two corrugated metal (CM) cutoff walls around pipe under each shoulder. Slide gate with control pedestal in CM pipe riser located on the waterside (WS) slope. Reinforced concrete discharge box is located on the WS toe. Flap gate is located on the WS end. Slide gate with control pedestal in collection sump located on the landside (LS). 60-inch discharge pipe extends from box across the berm to the riverbank. Pumping plant is located on the LS toe. (48-inch pipe abandoned and CM riser cut 2 feet below ground surface authorized under Permit No. 3596A, 1998 – City of Sacramento; three 30-inch and one 48-inch pipes authorized under Permit No. 3596, 3596A, 1962 - County of Sacramento Manlove Drainage Assessment District; 60-inch pipe authorized under Permit No. 5894, 1970 - City of Sacramento) [Additional Reference(s): DWR Levee Log, 2002] FS Date: 12/11/2013

Signs of crossing repair patch section visible on levee crown.

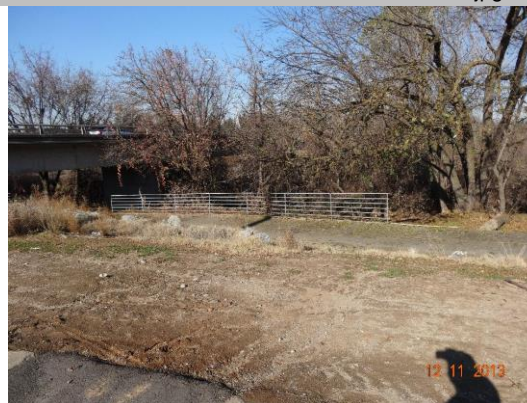
Photo 3 of 3 : UCIP_SP_2019_30023_55397.jpg

View of waterward side.

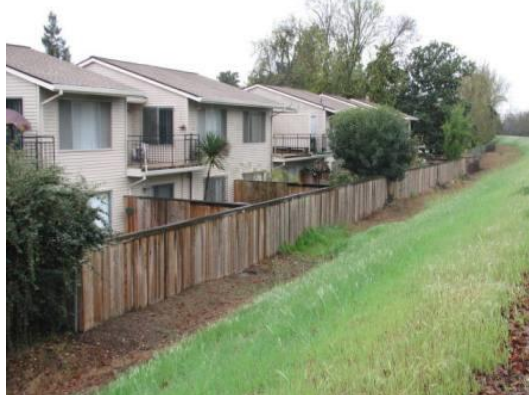
Photo 1 of 1 : SP_2019_NA0001_55_74_20190307_00061.jpg

LM Start	7.65	Rating **	U	Issue No.	74
LM End	7.68	Issue Type +	En	Location *	LS
Category	Earthen Levee			GPS Latitude/Longitude	
				Start	End
Item	Encroachments			38.559177 °	38.559218 °
				-121.403541 °	-121.402967 °
DWR ID	DWR_NA0001_04_s_2012_74				
Comment Code					
FE : Fence					
Inspector Comment					
Wooden privacy fence for seven apartment units is within 10-ft of levee toe and obstructs access and visibility.

03/16/2012 Wood privacy fence completely obstructs access and visibility.

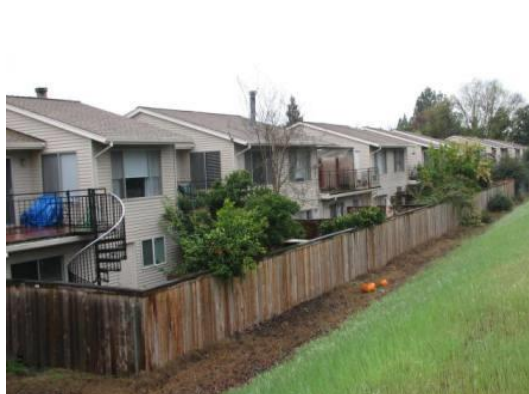
Photo 1 of 1 : SP_2019_NA0001_55_75_20190307_00062.jpg

LM Start	7.69	Rating **	U	Issue No.	75
LM End	7.72	Issue Type +	En	Location *	LS
Category	Earthen Levee			GPS Latitude/Longitude	
				Start	End
Item	Encroachments			38.559230 °	38.559261 °
				-121.402708 °	-121.402219 °
DWR ID	DWR_NA0001_04_s_2012_75				
Comment Code					
FE : Fence					
Inspector Comment					
Wooden privacy fence for seven apartment units is within 10-ft of levee toe and obstructs access and visibility.

03/16/2012 Wood privacy fence completely obstructs access and visibility.

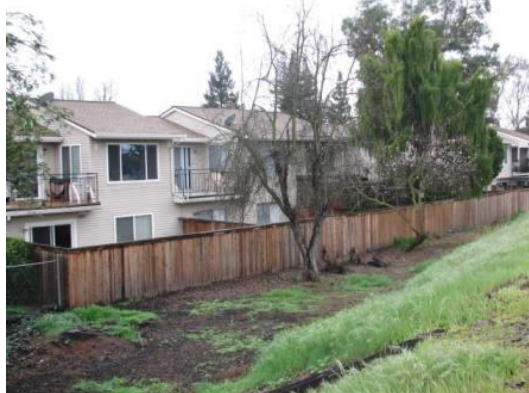
Photo 1 of 1 : SP_2019_NA0001_55_78_20190307_00065.jpg

LM Start	7.82	Rating **	U	Issue No.	78
LM End	7.84	Issue Type +	En	Location *	LS
Category	Earthen Levee			GPS Latitude/Longitude	
				Start	End
Item	Encroachments			38.559379 °	38.559435 °
				-121.400354 °	-121.399944 °
DWR ID	DWR_NA0001_04_s_2017_78				
Comment Code					
FE : Fence					
Inspector Comment					
Wooden privacy fence for seven apartment units is within 10-ft of levee toe and obstructs access and visibility.

03/16/2012 Wood privacy fence completely obstructs access and visibility.

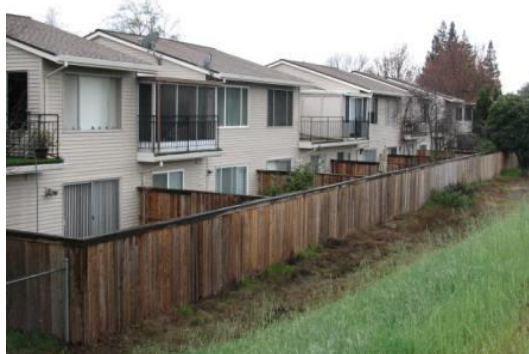
Photo 1 of 1 : SP_2019_NA0001_55_79_20190307_00066.jpg

LM Start	7.86	Rating **	U	Issue No.	79
LM End	7.88	Issue Type +	En	Location *	LS
Category	Earthen Levee			GPS Latitude/Longitude	
				Start	End
Item	Encroachments			38.559514 °	38.559643 °
				-121.399700 °	-121.399248 °
DWR ID	DWR_NA0001_04_s_2012_79				
Comment Code					
FE : Fence					
Inspector Comment					
Wooden privacy fence for seven apartment units is within 10-ft of levee toe and obstructs access and visibility.

03/16/2012 Wood privacy fence completely obstructs access and visibility.

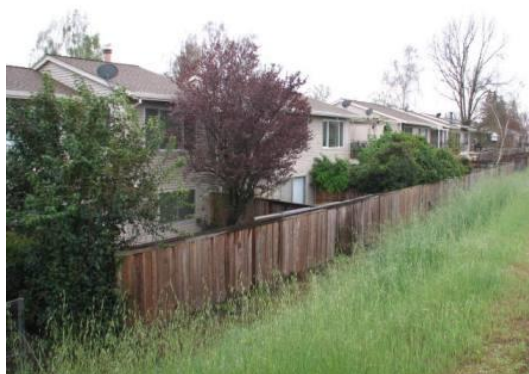
Photo 1 of 1 : SP_2019_NA0001_55_80_20190307_00067.jpg

LM Start	7.90	Rating **	U	Issue No.	80
LM End	7.93	Issue Type +	En	Location *	LS
Category	Earthen Levee			GPS Latitude/Longitude	
				Start	End
Item	Encroachments			38.559753 °	38.559911 °
				-121.398982 °	-121.398506 °
DWR ID	DWR_NA0001_04_s _ 2012_80				
Comment Code					
FE : Fence					
Inspector Comment					
Wooden privacy fence for seven apartment units is within 10-ft of levee toe and obstructs access and visibility. Concrete steps were also placed on slope.

03/16/2012 Wood privacy fence completely obstructs access and visibility.

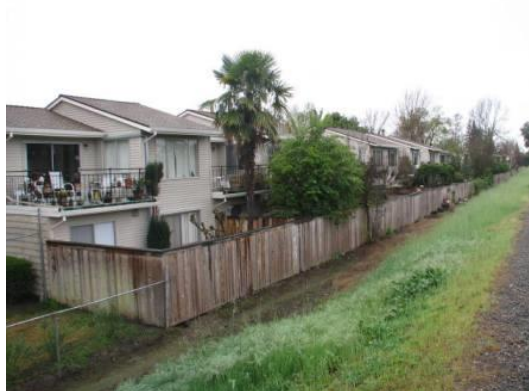
Photo 1 of 2 : SP_2019_NA0001_55_224_20190307_00182.jpg

LM Start	7.94	Rating **	U	Issue No.	224
LM End	8.02	Issue Type +	En	Location *	LS
Category	Earthen Levee			GPS Latitude/Longitude	
				Start	End
Item	Encroachments			38.559968 °	38.560505 °
				-121.398330 °	-121.396989 °
DWR ID	DWR_NA0001_04_s _ 2012_224				
Comment Code					
FE : Fence					
Inspector Comment					
Wooden privacy fence for seven apartment units is within 10-ft of levee toe and obstructs access and visibility.

03/16/2012 Wood privacy fence completely obstructs access and visibility.

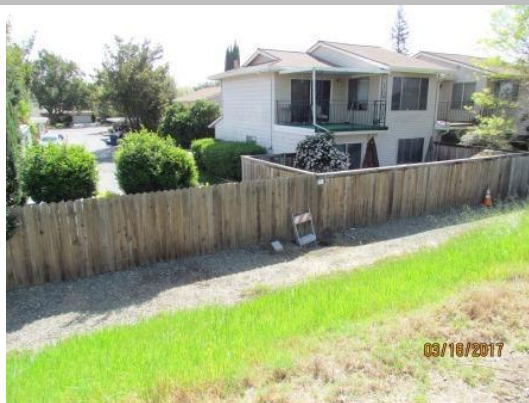
Photo 2 of 2 : SP_2019_NA0001_55_224_20190307_00183.jpg

LM Start	7.94	Rating **	U	Issue No.	224 (cont)
LM End	8.02	Issue Type +	En	Location *	LS
Category	Earthen Levee			GPS Latitude/Longitude	
				Start	End
Item	Encroachments			38.559968 °	38.560505 °
				-121.398330 °	-121.396989 °
DWR ID	DWR_NA0001_04_s _ 2012_224				
Comment Code					
FE : Fence					
Inspector Comment					
Wooden privacy fence for seven apartment units is within 10-ft of levee toe and obstructs access and visibility.

Another view of the fence at the levee toe.

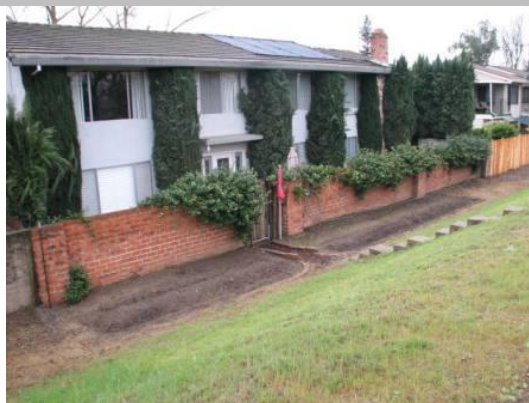
Photo 1 of 1 : SP_2019_NA0001_55_82_20190307_00068.jpg

LM Start	8.02	Rating **	U	Issue No.	82
LM End	8.02	Issue Type +	En	Location *	LS
Category	Earthen Levee			GPS Latitude/Longitude	
				Start	End
Item	Encroachments			38.560537 °	38.560537 °
				-121.396912 °	-121.396912 °
DWR ID	DWR_NA0001_04_s _ 2012_82				
Comment Code					
FE : Fence					
Inspector Comment					
Brick fence is within 10-ft of levee toe, obstructing access and visibility. Stairs are also on the levee slope.

03/16/2012 Brick wall completely obstructs access and visibility.

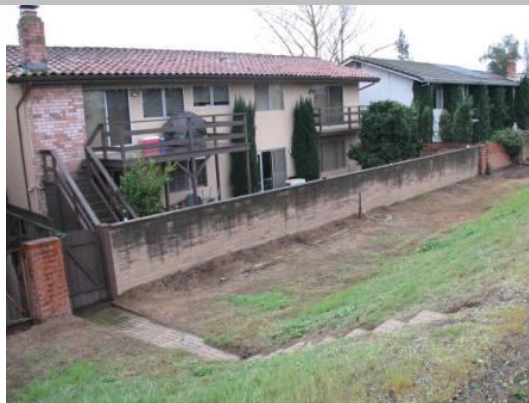
Photo 1 of 1 : SP_2019_NA0001_55_83_20190307_00069.jpg

LM Start	8.04	Rating **	U	Issue No.	83
LM End	8.04	Issue Type +	En	Location *	LS
Category	Earthen Levee			GPS Latitude/Longitude	
				Start	End
Item	Encroachments			38.560647 °	38.560647 °
				-121.396660 °	-121.396660 °
DWR ID	DWR_NA0001_04_s _ 2012_83				
Comment Code					
FE : Fence					
Inspector Comment					
Brick fence is within 10-ft of levee toe and obstructs access and visibility. Brick stairs do not appear to be permitted.

03/16/2012 Brick wall completely obstructs access and visibility.

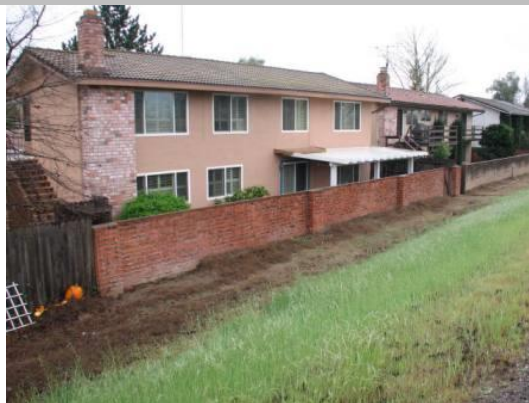
Photo 1 of 1 : SP_2019_NA0001_55_84_20190307_00070.jpg

LM Start	8.05	Rating **	U	Issue No.	84
LM End	8.05	Issue Type +	En	Location *	LS
Category	Earthen Levee			GPS Latitude/Longitude	
				Start	End
Item	Encroachments			38.560728 °	38.560728 °
				-121.396471 °	-121.396471 °
DWR ID	DWR_NA0001_04_s _ 2012_84				
Comment Code					
FE : Fence					
Inspector Comment					
Brick fence is within 10-ft of levee toe and obstructs access and visibility.

03/16/2012 Brick wall completely obstructs access and visibility.

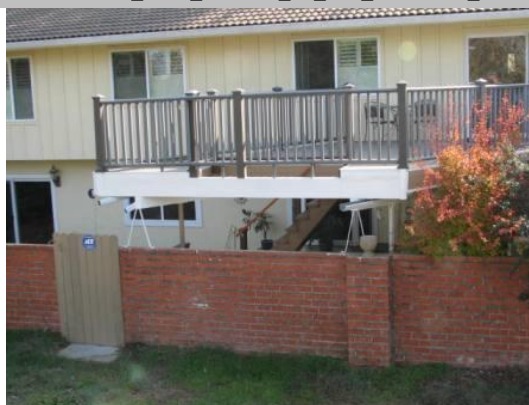
Photo 1 of 1 : SP_2019_NA0001_55_745_20190307_00212.jpg

LM Start	8.07	Rating **	A/W	Issue No.	745
LM End	8.07	Issue Type +	En	Location *	LS
Category	Earthen Levee			GPS Latitude/Longitude	
				Start	End
Item	Encroachments			38.560823 °	38.560823 °
				-121.396208 °	-121.396208 °
DWR ID	DWR_NA0001_04_s _ 2012_745				
Comment Code					
UR : Urban					
Inspector Comment					
Drains direct gutter flow onto levee toe.

11/15/2011 Gutter drains that are suspended from the balcony direct flow onto the levee toe.

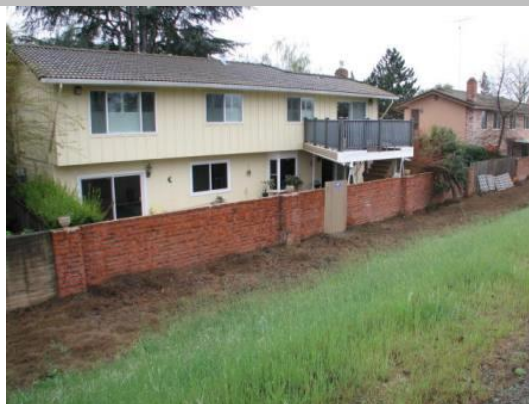
Photo 1 of 1 : SP_2019_NA0001_55_85_20190307_00071.jpg

LM Start	8.07	Rating **	U	Issue No.	85
LM End	8.07	Issue Type +	En	Location *	LS
Category	Earthen Levee			GPS Latitude/Longitude	
				Start	End
Item	Encroachments			38.560845 °	38.560845 °
				-121.396189 °	-121.396189 °
DWR ID	DWR_NA0001_04_s _ 2012_85				
Comment Code					
FE : Fence					
Inspector Comment					
Brick fence is within 10-ft of levee toe and obstructs access and visibility.

03/16/2012 Brick wall completely obstructs access and visibility.

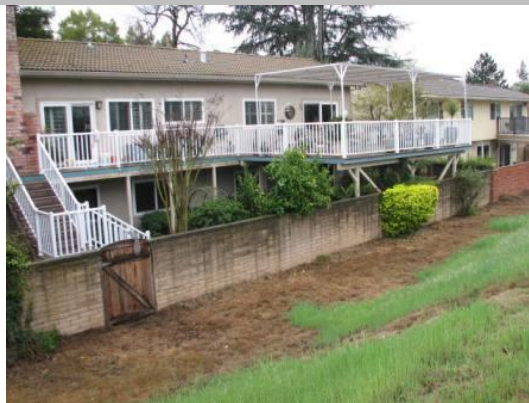
Photo 1 of 1 : SP_2019_NA0001_55_86_20190307_00072.jpg

LM Start	8.08	Rating **	U	Issue No.	86
LM End	8.08	Issue Type +	En	Location *	LS
Category	Earthen Levee			GPS Latitude/Longitude	
				Start	End
Item	Encroachments			38.560907 °	38.560907 °
				-121.396043 °	-121.396043 °
DWR ID	DWR_NA0001_04_s _ 2012_86				
Comment Code					
FE : Fence					
Inspector Comment					
Brick fence is within 10-ft of levee toe and obstructs access and visibility. Paver stairs do not appear to be authorized.

03/16/2012 Brick wall completely obstructs access and visibility.

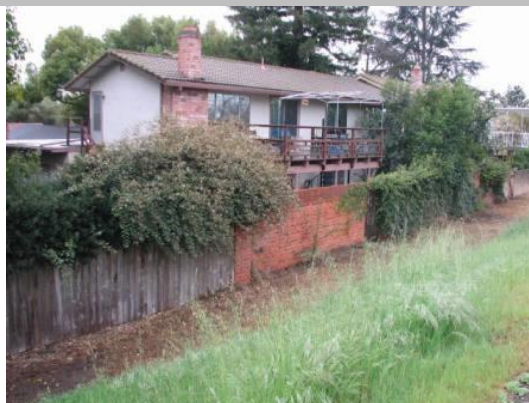
Photo 1 of 1 : SP_2019_NA0001_55_87_20190307_00073.jpg

LM Start	8.09	Rating **	U	Issue No.	87
LM End	8.09	Issue Type +	En	Location *	LS
Category	Earthen Levee			GPS Latitude/Longitude	
				Start	End
Item	Encroachments			38.561008 °	38.561008 °
				-121.395817 °	-121.395817 °
DWR ID	DWR_NA0001_04_s _ 2012_87				
Comment Code					
FE : Fence					
Inspector Comment					
Brick fence is within 10-ft of levee toe and obstructs access and visibility.

03/16/2012 Brick wall completely obstructs access and visibility.

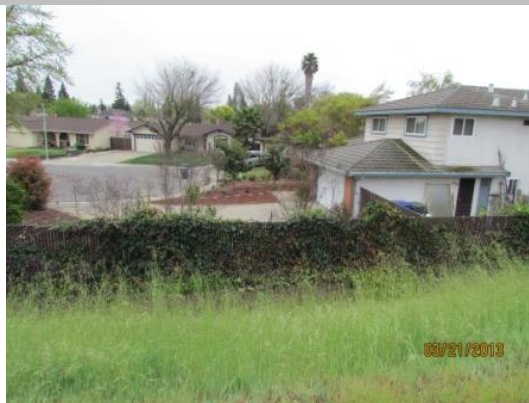
Photo 1 of 1 : SP_2019_NA0001_55_225_20190307_00184.jpg

LM Start	8.11	Rating **	M	Issue No.	225
LM End	8.13	Issue Type +	En	Location *	LS
Category	Earthen Levee			GPS Latitude/Longitude	
				Start	End
Item	Vegetation			38.561145 °	38.561248 °
				-121.395407 °	-121.395169 °
DWR ID	DWR_NA0001_04_s _ 2012_225				
Comment Code					
V6 : Landscaping					
Inspector Comment					
Landscaping along chain link fence within 10-ft of levee toe obstructs access and visibility.

View of the landscaping at the levee toe.

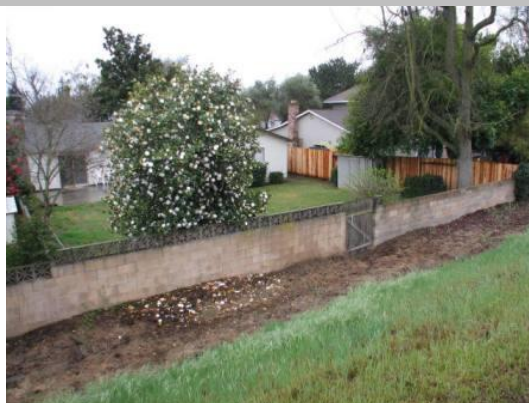
Photo 1 of 1 : SP_2019_NA0001_55_90_20190307_00076.jpg

LM Start	8.17	Rating **	U	Issue No.	90
LM End	8.17	Issue Type +	En	Location *	LS
Category	Earthen Levee			GPS Latitude/Longitude	
				Start	End
Item	Encroachments			38.561544 °	38.561544 °
				-121.394494 °	-121.394494 °
DWR ID	DWR_NA0001_04_s_2019_90				
Comment Code					
FE : Fence					
Inspector Comment					
Cement block fence is within 10-ft of the levee toe.

03/16/2012 Cinder block wall completely obstructs access and visibility.

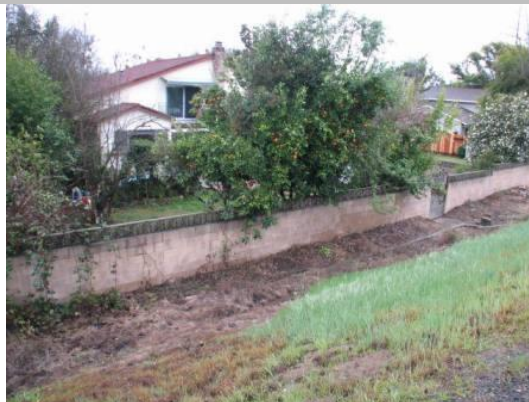
Photo 1 of 1 : SP_2019_NA0001_55_91_20190307_00077.jpg

LM Start	8.18	Rating **	U	Issue No.	91
LM End	8.18	Issue Type +	En	Location *	LS
Category	Earthen Levee			GPS Latitude/Longitude	
				Start	End
Item	Encroachments			38.561593 °	38.561593 °
				-121.394315 °	-121.394315 °
DWR ID	DWR_NA0001_04_s_2012_91				
Comment Code					
FE : Fence					
Inspector Comment					
Concrete block fence and landscaping within 10-ft of levee toe obstruct access and visibility.

03/16/2012 Cinder block wall completely obstructs access and visibility.

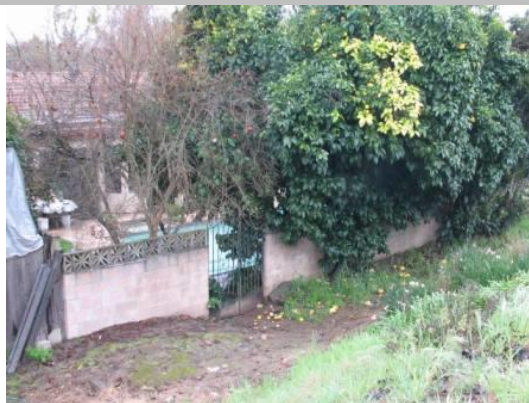
Photo 1 of 1 : SP_2019_NA0001_55_92_20190307_00078.jpg

LM Start	8.19	Rating **	U	Issue No.	92
LM End	8.19	Issue Type +	En	Location *	LS
Category	Earthen Levee			GPS Latitude/Longitude	
				Start	End
Item	Encroachments			38.561658 °	38.561658 °
				-121.394157 °	-121.394157 °
DWR ID	DWR_NA0001_04_s _ 2012_92				
Comment Code					
FE : Fence					
Inspector Comment					
Cement block fence and landscaping within 10-ft of levee toe obstruct access and visibility.

03/16/2012 Cinder block fence completely obstructs access and visibility.

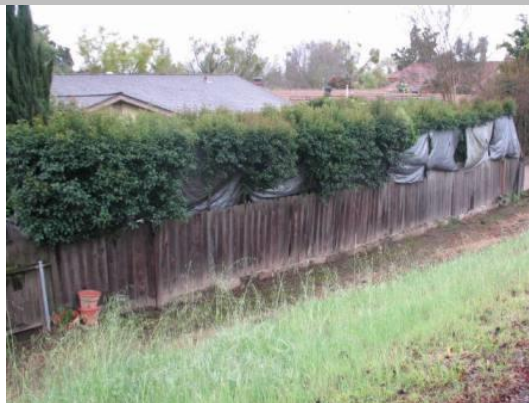
Photo 1 of 1 : SP_2019_NA0001_55_93_20190307_00079.jpg

LM Start	8.21	Rating **	U	Issue No.	93
LM End	8.21	Issue Type +	En	Location *	LS
Category	Earthen Levee			GPS Latitude/Longitude	
				Start	End
Item	Encroachments			38.561750 °	38.561750 °
				-121.393917 °	-121.393917 °
DWR ID	DWR_NA0001_04_s _ 2012_93				
Comment Code					
FE : Fence					
Inspector Comment					
Wooden fence and landscaping within 10-ft of levee toe obstruct access and visibility.

03/16/2012 Wood privacy fence completely obstructs access and visibility.

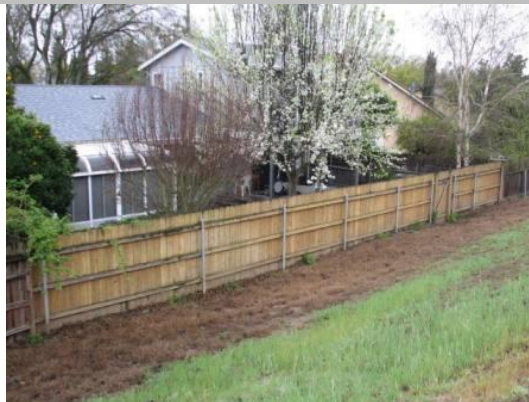
Photo 1 of 1 : SP_2019_NA0001_55_95_20190307_00081.jpg

LM Start	8.23	Rating **	U	Issue No.	95
LM End	8.23	Issue Type +	En	Location *	LS
Category	Earthen Levee			GPS Latitude/Longitude	
				Start	End
Item	Encroachments			38.561900 °	38.561900 °
				-121.393547 °	-121.393547 °
DWR ID	DWR_NA0001_04_s_2012_95				
Comment Code					
FE : Fence					
Inspector Comment					
Wood privacy fence within 10-ft of levee toe obstructs access and visibility.

03/16/2012 Wood privacy fence completely obstructs access and visibility.

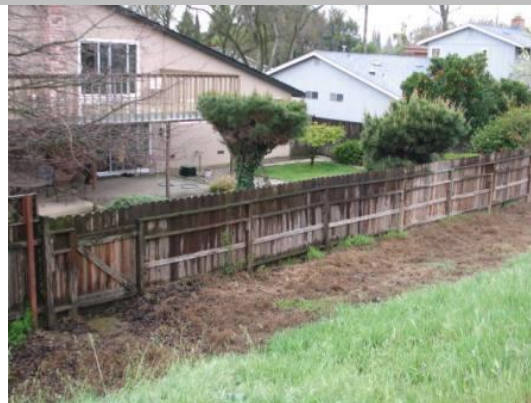
Photo 1 of 1 : SP_2019_NA0001_55_97_20190307_00083.jpg

LM Start	8.24	Rating **	U	Issue No.	97
LM End	8.24	Issue Type +	En	Location *	LS
Category	Earthen Levee			GPS Latitude/Longitude	
				Start	End
Item	Encroachments			38.561977 °	38.561977 °
				-121.393338 °	-121.393338 °
DWR ID	DWR_NA0001_04_s _ 2017_97				
Comment Code					
FE : Fence					
Inspector Comment					
Wood privacy fence within 10-ft of levee toe obstructs access and visibility.

03/16/2012 Wood privacy fence completely obstructs access and visibility.

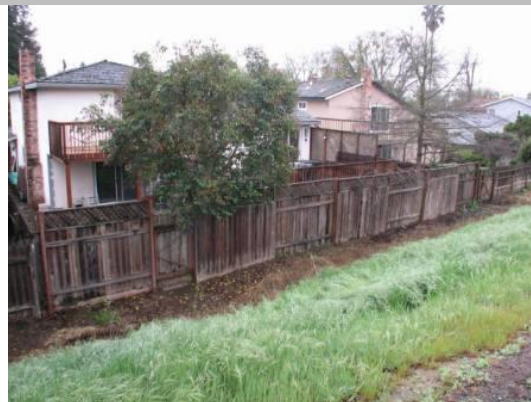
Photo 1 of 1 : SP_2019_NA0001_55_98_20190307_00084.jpg

LM Start	8.25	Rating **	U	Issue No.	98
LM End	8.25	Issue Type +	En	Location *	LS
Category	Earthen Levee			GPS Latitude/Longitude	
				Start	End
Item	Encroachments			38.562054 °	38.562054 °
				-121.393190 °	-121.393190 °
DWR ID	DWR_NA0001_04_s _ 2012_98				
Comment Code					
FE : Fence					
Inspector Comment					
Wood privacy fence within 10-ft of levee toe obstructs access and visibility.

03/16/2012 Wood privacy fence completely obstructs access and visibility.

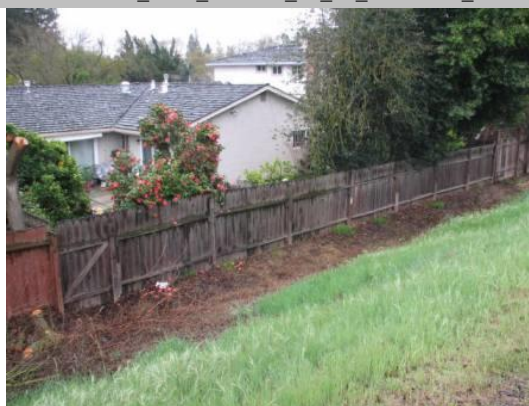
Photo 1 of 1 : SP_2019_NA0001_55_99_20190307_00085.jpg

LM Start	8.26	Rating **	U	Issue No.	99
LM End	8.26	Issue Type +	En	Location *	LS
Category	Earthen Levee			GPS Latitude/Longitude	
				Start	End
Item	Encroachments			38.562120 °	38.562120 °
				-121.392983 °	-121.392983 °
DWR ID	DWR_NA0001_04_s _ 2012_99				
Comment Code					
FE : Fence					
Inspector Comment					
Wood privacy fence within 10-ft of levee toe obstructs access and visibility.

03/16/2012 Wood privacy fence completely obstructs access and visibility.

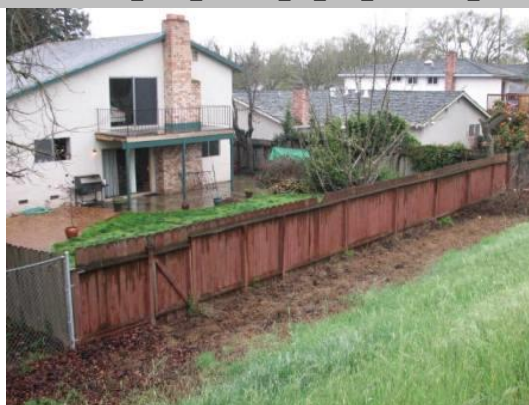
Photo 1 of 1 : SP_2019_NA0001_55_100_20190307_00086.jpg

LM Start	8.27	Rating **	U	Issue No.	100
LM End	8.27	Issue Type +	En	Location *	LS
Category	Earthen Levee			GPS Latitude/Longitude	
				Start	End
Item	Encroachments			38.562182 °	38.562182 °
				-121.392778 °	-121.392778 °
DWR ID	DWR_NA0001_04_s _ 2012_100				
Comment Code					
FE : Fence					
Inspector Comment					
Wood privacy fence within 10-ft of levee toe obstructs access and visibility.

03/16/2012 Wood privacy fence completely obstructs access and visibility.

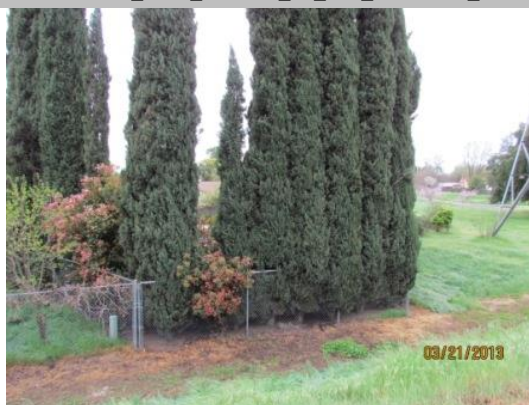
Photo 1 of 1 : SP_2019_NA0001_55_102_20190307_00088.jpg

LM Start	8.38	Rating **	M	Issue No.	102
LM End	8.38	Issue Type +	En	Location *	LS
Category	Earthen Levee			GPS Latitude/Longitude	
				Start	End
Item	Vegetation			38.562889 °	38.562889 °
				-121.391042 °	-121.391042 °
DWR ID	DWR_NA0001_04_s_2012_102				
Comment Code					
V6 : Landscaping					
Inspector Comment					
Helix sky pencil along chain link fence is within 10-ft of the levee toe.

View of the landscaping at the levee toe.

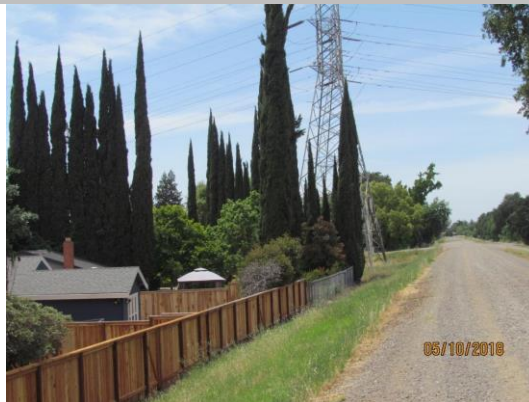
Photo 1 of 1 : SP_2019_NA0001_55_103_20190307_00089.jpg

LM Start	8.40	Rating **	U	Issue No.	103
LM End	8.41	Issue Type +	En	Location *	LS
Category	Earthen Levee			GPS Latitude/Longitude	
				Start	End
Item	Encroachments			38.563042 °	38.563083 °
				-121.390692 °	-121.390600 °
DWR ID	DWR_NA0001_04_s_2012_103				
Comment Code					
FE : Fence					
Inspector Comment					
Wood privacy fence within 10-ft of levee toe obstructs access and visibility.

View looking downstream landside of the wood privacy fence that completely obstructs access and visibility, Spring 2018.

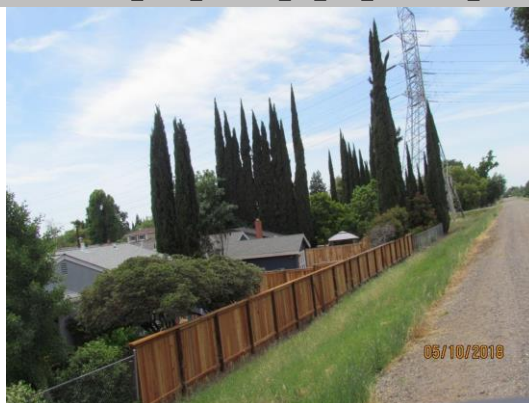
Photo 1 of 1 : SP_2019_NA0001_55_104_20190307_00091.jpg

LM Start	8.42	Rating **	U	Issue No.	104
LM End	8.42	Issue Type +	En	Location *	LS
Category	Earthen Levee			GPS Latitude/Longitude	
				Start	End
Item	Encroachments			38.563129 °	38.563129 °
				-121.390406 °	-121.390406 °
DWR ID	DWR_NA0001_04_s_2012_104				
Comment Code					
FE : Fence					
Inspector Comment					
Wood privacy fence within 10-ft of levee toe obstructs access and visibility.

View looking downstream landside of the wood privacy fence that completely obstructs access and visibility, Spring 2018.

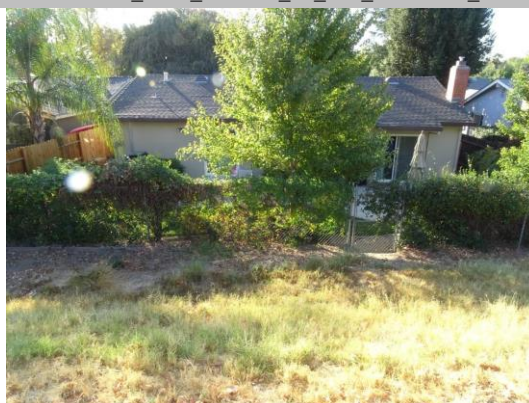
Photo 1 of 1 : SP_2019_NA0001_55_258_20190307_00200.jpg

LM Start	8.43	Rating **	M	Issue No.	258
LM End	8.43	Issue Type +	En	Location *	LS
Category	Earthen Levee			GPS Latitude/Longitude	
				Start	End
Item	Vegetation			38.563208 °	38.563208 °
				-121.390226 °	-121.390226 °
DWR ID	DWR_NA0001_04_f_2018_258				
Comment Code					
V6 : Landscaping					
Inspector Comment					
Vines on chainlink fence block visibility of levee toe.

View of vines on fence that block visibility of levee toe. Fall 2018

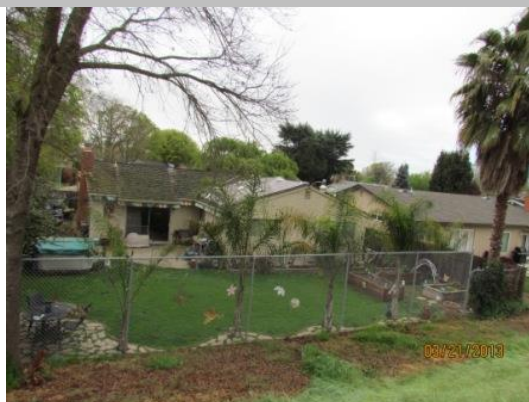
Photo 1 of 1 : SP_2019_NA0001_55_105_20190307_00093.jpg

LM Start	8.44	Rating **	M	Issue No.	105
LM End	8.44	Issue Type +	En	Location *	LS
Category	Earthen Levee			GPS Latitude/Longitude	
				Start	End
Item	Vegetation			38.563238 °	38.563238 °
				-121.390073 °	-121.390073 °
DWR ID	DWR_NA0001_04_s_2012_105				
Comment Code					
V6 : Landscaping					
Inspector Comment					
Palms were planted within 10-ft of the levee toe.

View of the palm trees at the levee toe.

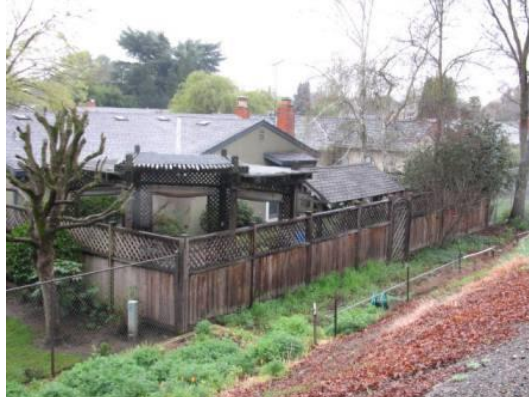
Photo 1 of 1 : SP_2019_NA0001_55_106_20190307_00094.jpg

LM Start	8.45	Rating **	U	Issue No.	106
LM End	8.45	Issue Type +	En	Location *	LS
Category	Earthen Levee			GPS Latitude/Longitude	
				Start	End
Item	Encroachments			38.563308 °	38.563308 °
				-121.389885 °	-121.389885 °
DWR ID	DWR_NA0001_04_s_2012_106				
Comment Code					
FE : Fence					
Inspector Comment					
Wood privacy fence within 10-ft of levee toe obstructs access and visibility.

03/16/2012 Wood privacy fence completely obstructs access and visibility.

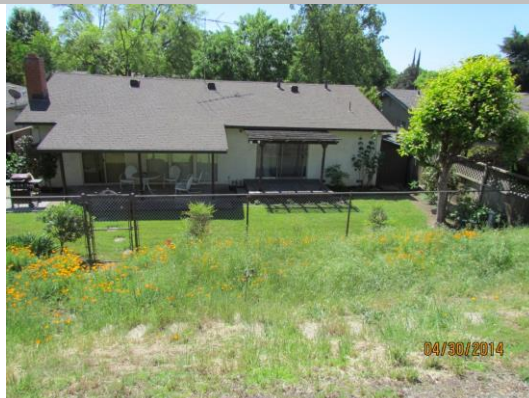
Photo 1 of 1 : SP_2019_NA0001_55_246_20190307_00196.jpg

LM Start	8.46	Rating **	M	Issue No.	246
LM End	8.46	Issue Type +	En	Location *	LS
Category	Earthen Levee			GPS Latitude/Longitude	
				Start	End
Item	Encroachments			38.563434 °	38.563434 °
				-121.389675 °	-121.389675 °
DWR ID	DWR_NA0001_04_s_2014_246				
Comment Code					
RW : Retaining Wall					
Inspector Comment					
Retaining wall, concrete steps, and irrigation lines are at the landside levee toe.

View of the irrigation and retaining wall at the landside levee toe.
